What Constitutes a Gas Bag ?

by John Davis

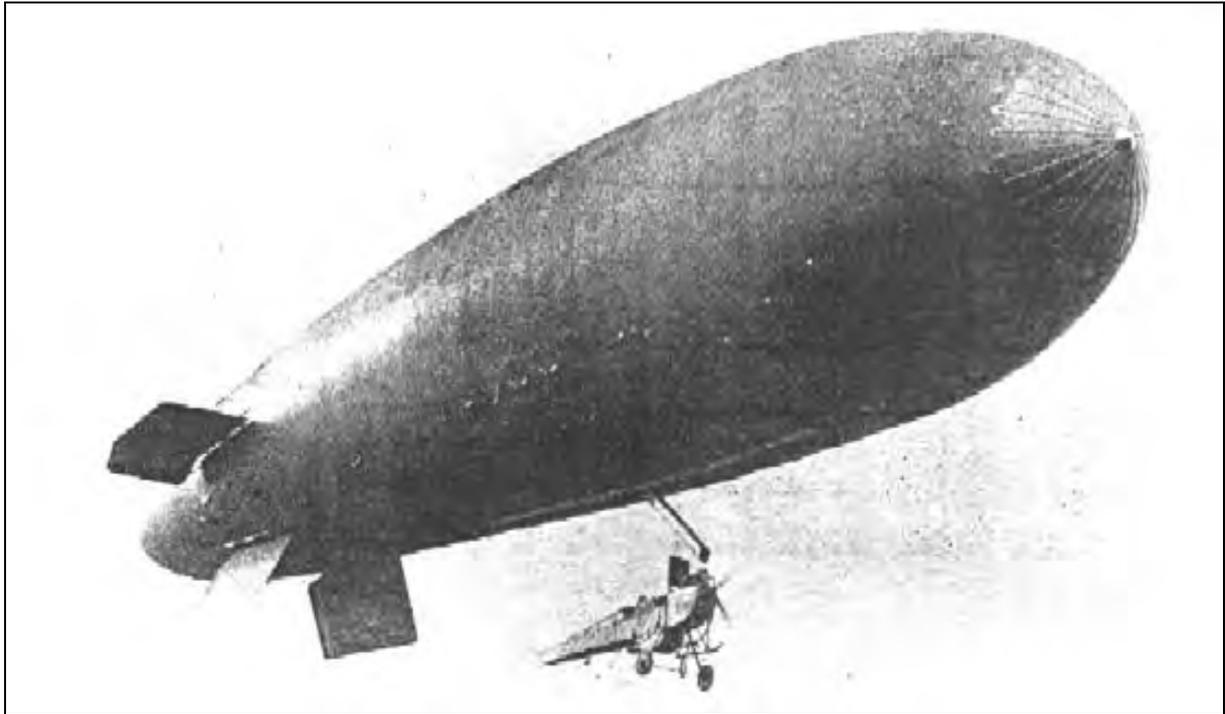
The first Sea Scout airship.
